Evaluation of Ultra High Molecular Weight (UHMW) Polyethylene Panels for Aircraft Arresting Systems

E. Ray Brown

August 2009

Final report

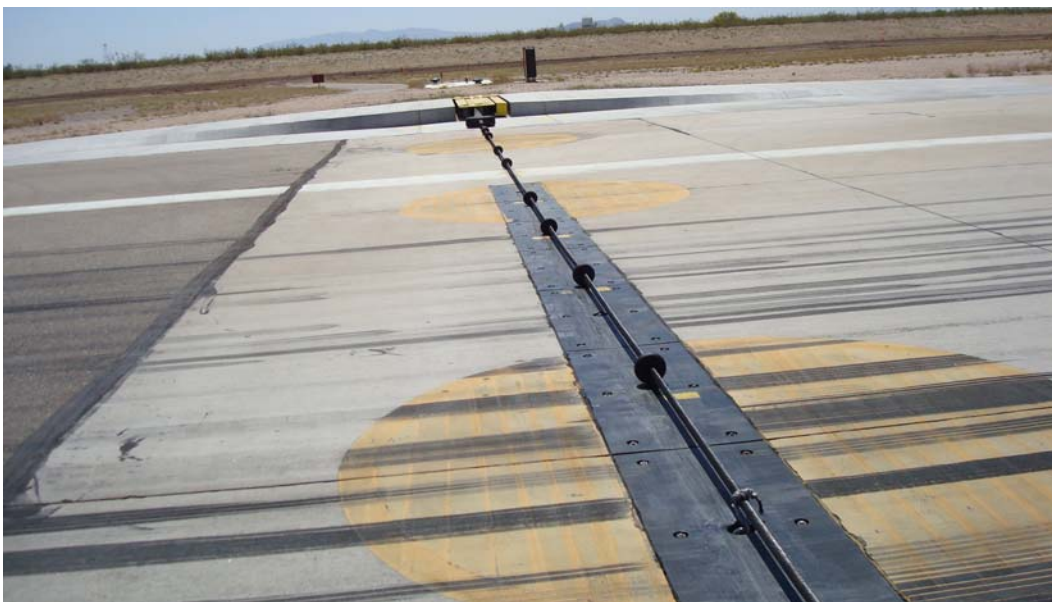
The panels at Davis-Monthan AFB were inspected on April 16, 2008. The barrier, which was constructed approximately 9 to 10 years prior to the inspection, consisted of panels placed in concrete with the concrete extending approximately 10 ft on one side of the panel and then changing to asphalt mixture (Figure 14). The concrete continued out past the recommended 200 ft on the opposite side of the barrier.

Figure 14. UHMW polyethylene panels at Davis-Monthan AFB within approximately 10 ft of change in pavement type.

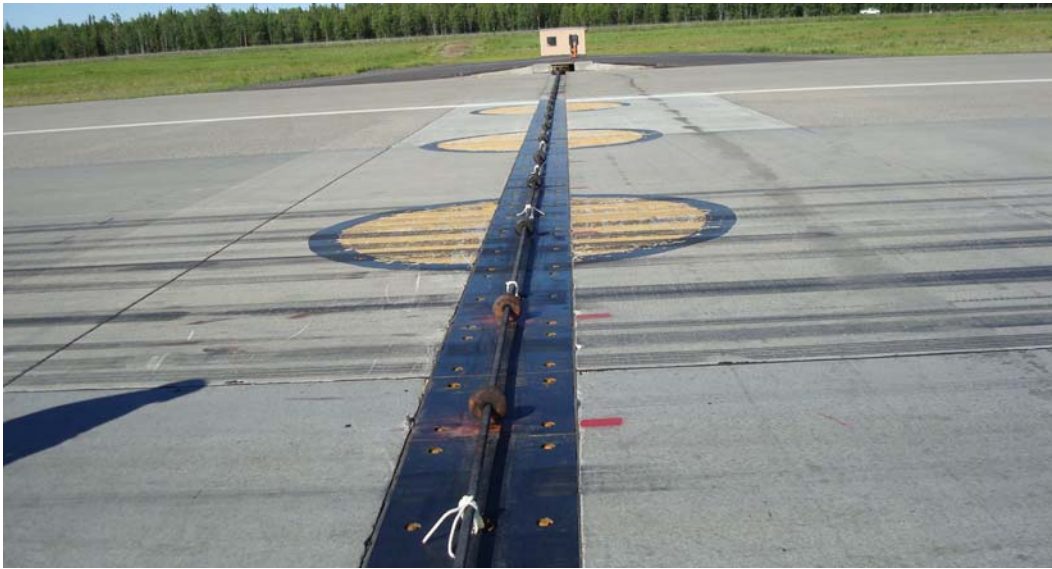
The panels at Eielson AFB were inspected on June 25, 2008. Each of the two arresting systems inspected consisted of panels placed in concrete with the concrete extending out over 200 ft in both directions (Figure 19). The panels on the south end of the runway were constructed in 2001, and the panels on the north end of the runway were constructed in 1995.

Figure 19. Overview of UHMW polyethylene panels at Eielson AFB showing concrete on both sides of the panels (south end of runway).

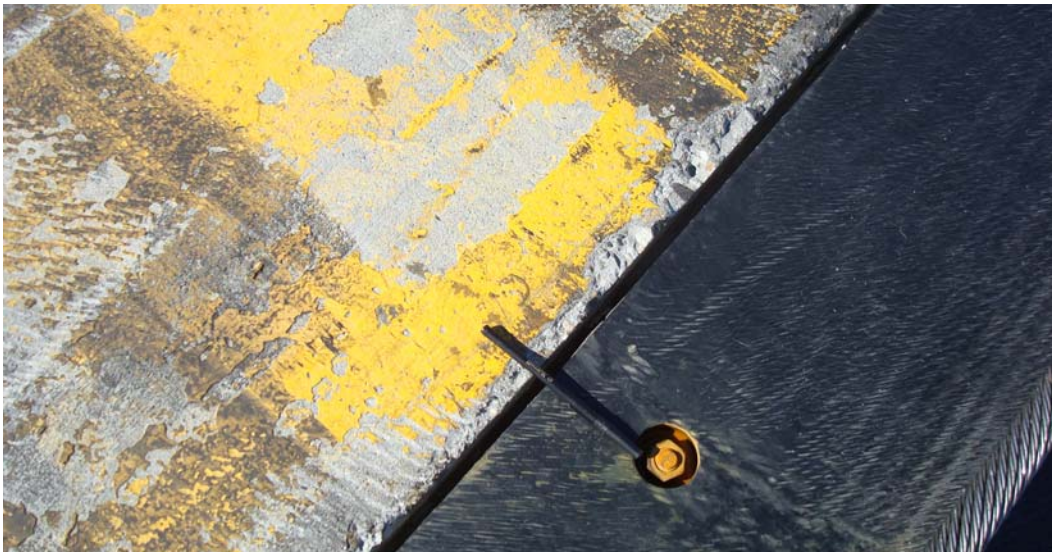
The joints had been sealed, but in many spots the sealant had been completely removed (Figure 20). Figure 20 shows some spalling in the concrete adjacent to the panels. This spalling was likely caused by snow removal equipment but could have been caused by incompressibles in the joints or by the cable beating against the concrete. In the best locations,

Figure 20. Loss of joint sealer between panels and concrete pavement (south end of runway) at Eielson AFB.

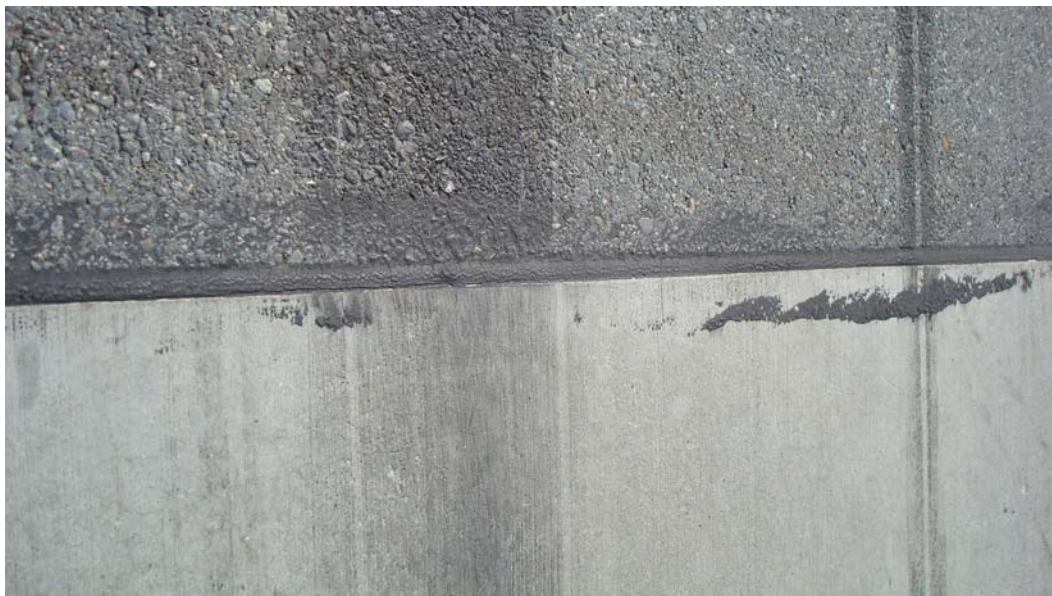
Figure 35. Condition of sealant between the concrete and asphalt pavements was generally good on Runway 24 at Elmendorf AFB.

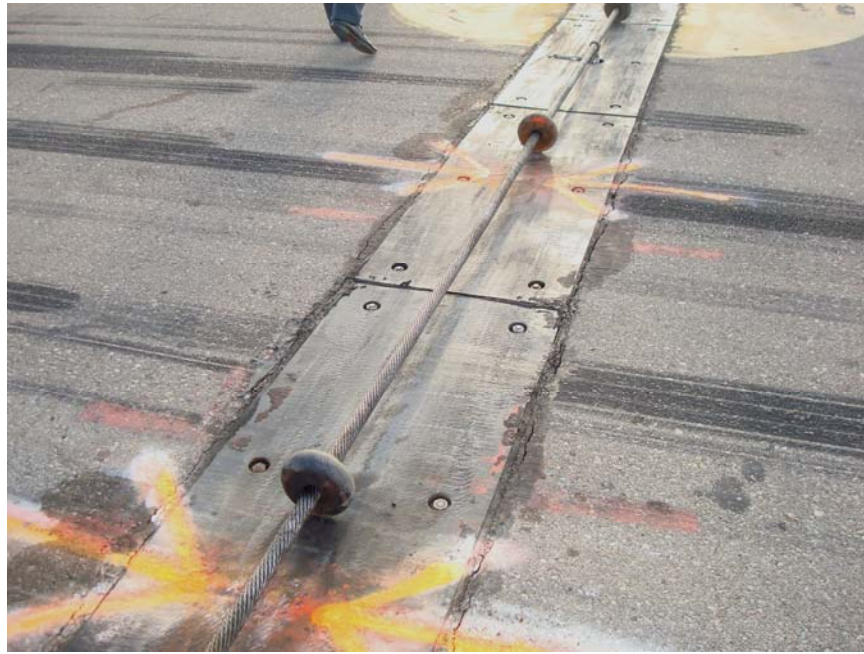
The age of the pavement and panels and the condition of the sealant, pavement, and panels on the 04 end was very similar to that on the 22 end (Figures 46 and 47). There was some warping of the panels, sometimes causing the edges of the panels to be higher than the adjacent pavement surface. The civil engineering staff at Holloman AFB made an effort to maintain the surface of the panels slightly below that of the adjacent pavement.

Figure 46. Overview of barrier cable on Runway 04 at Holloman AFB.

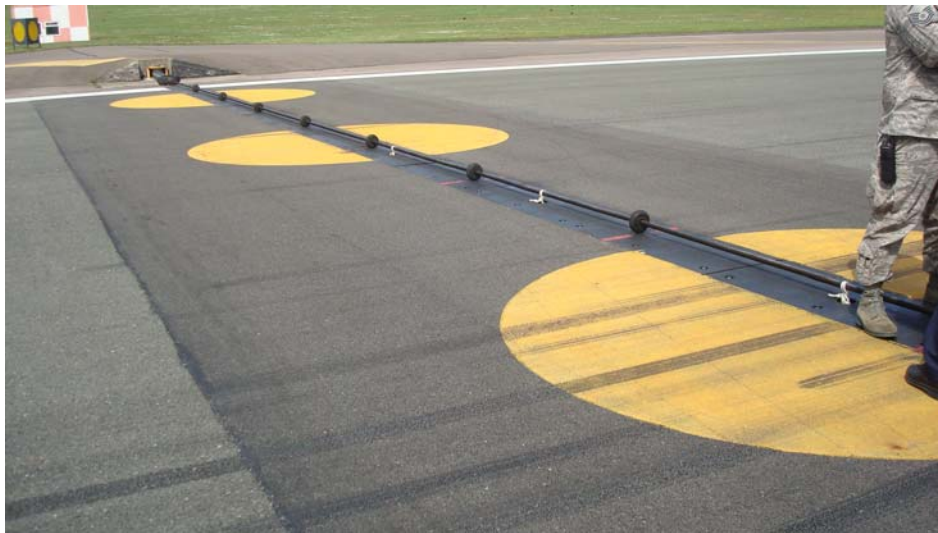
The pavement and panels at RAF Lakenheath were inspected on May 5, 2008. The pavement surface course was a porous friction course (PFC) that was about 15 years old. The panels were placed in 2007, so they were about 1 year old at the time of inspection (Figure 50). It appears that the

Figure 50. Overview of panels at RAF Lakenheath.

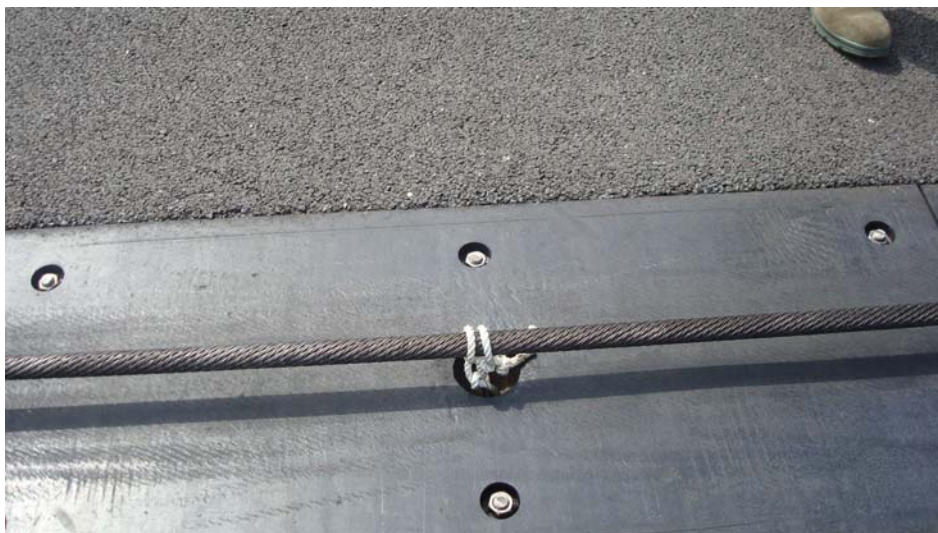
friction course was milled transversely for about 10 ft on each side of the panels. This was done to allow a transverse lane to be placed adjacent to the panels. The PFC immediately adjacent to the panels was placed when the panels were placed in 2007. The adjacent pavement was in very good shape (Figures 50 and 51), and the pavement outside this transverse strip of PFC was also in good shape especially considering that it was about 15 years old (Figure 52).

Figure 51. Condition of pavement adjacent to panels at RAF Lakenheath.

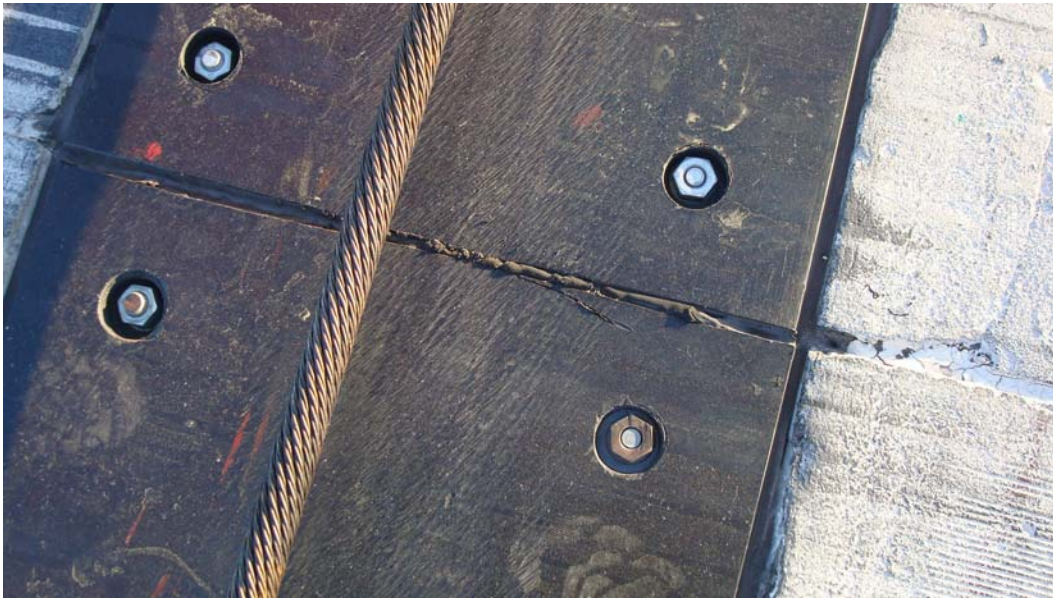
The sealer appeared to be in good condition in most cases; however, there were some places where the sealer had pulled away from the panel or concrete. Many of the recesses at the openings cut for the anchors did not contain sealer (Figure 86).

Figure 86. Barrier cable at Runway 13 L at Tyndall AFB showing no sealant in anchor recess.

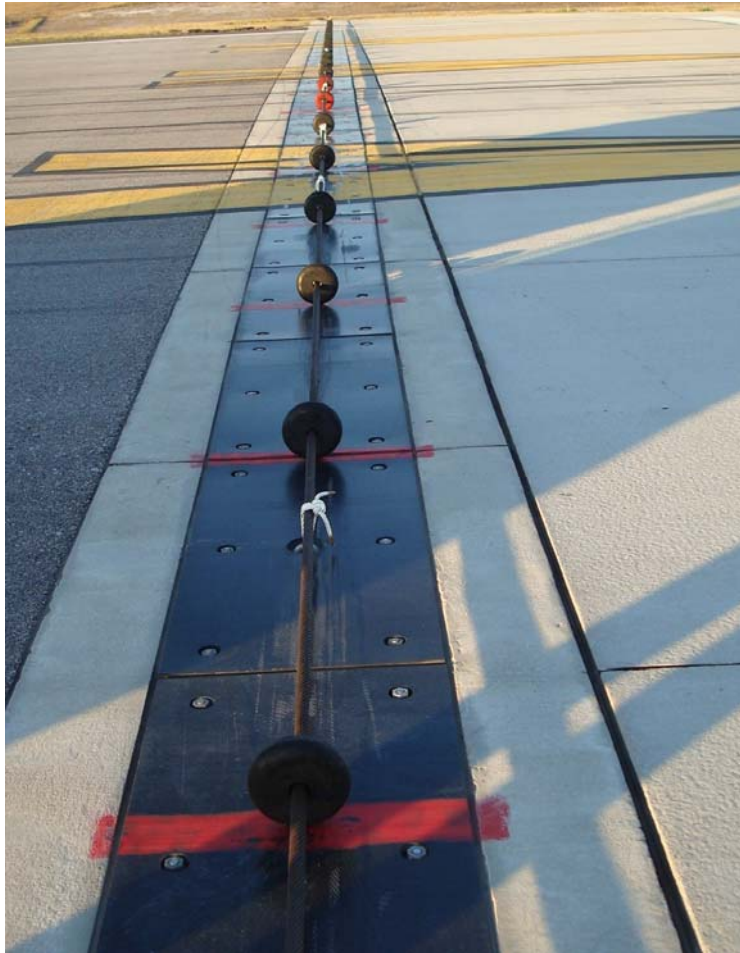
An overview image of Runway 31 L (E-5) is shown as Figure 95. There is concrete on one side of the panels and asphalt on the opposite side. On the side with asphalt, there is approximately a 1-ft strip of concrete between the panels and the asphalt.

Figure 95. Overview of panels (E-5) at Runway 31 L at Tyndall AFB.

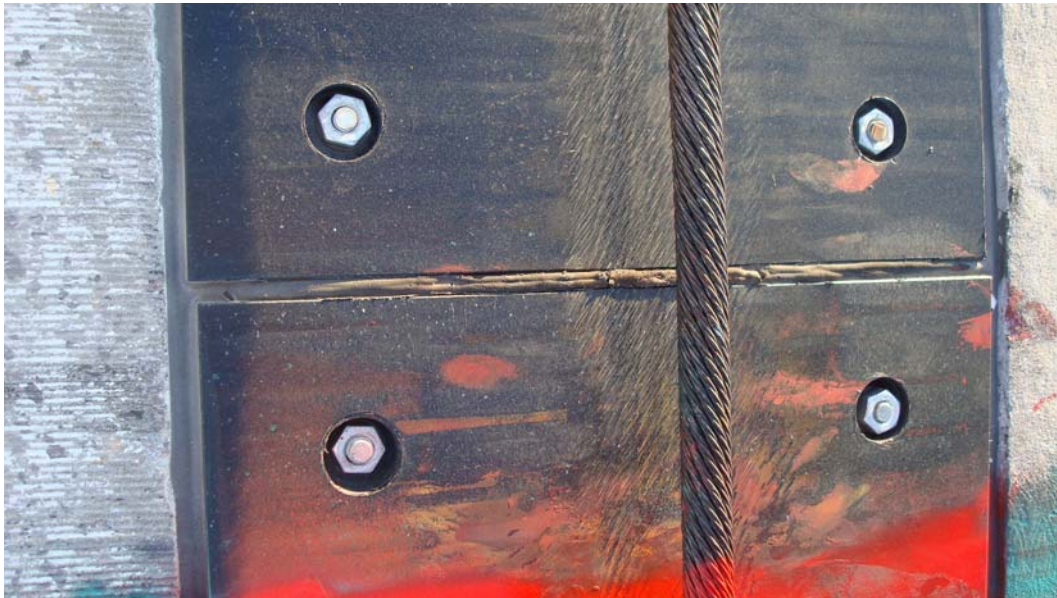
The sealant between the panels and the adjacent concrete was in good condition, but the sealant in the joints between the panels had lost its bond to the panels (Figure 100). This loss of bond is due to the large amount of movement during temperature changes. The joint generally reduces from an opening of up to 1 in. during cold weather to nearly closed during hot weather. It is very difficult for a sealant to perform satisfactorily with this high amount of movement.

Figure 100. Loss of sealant effectiveness at joint between panels at Runway 13 R at Tyndall AFB.
